Appendix F

Part 2

Figures

Clear Creek PCB Contamination

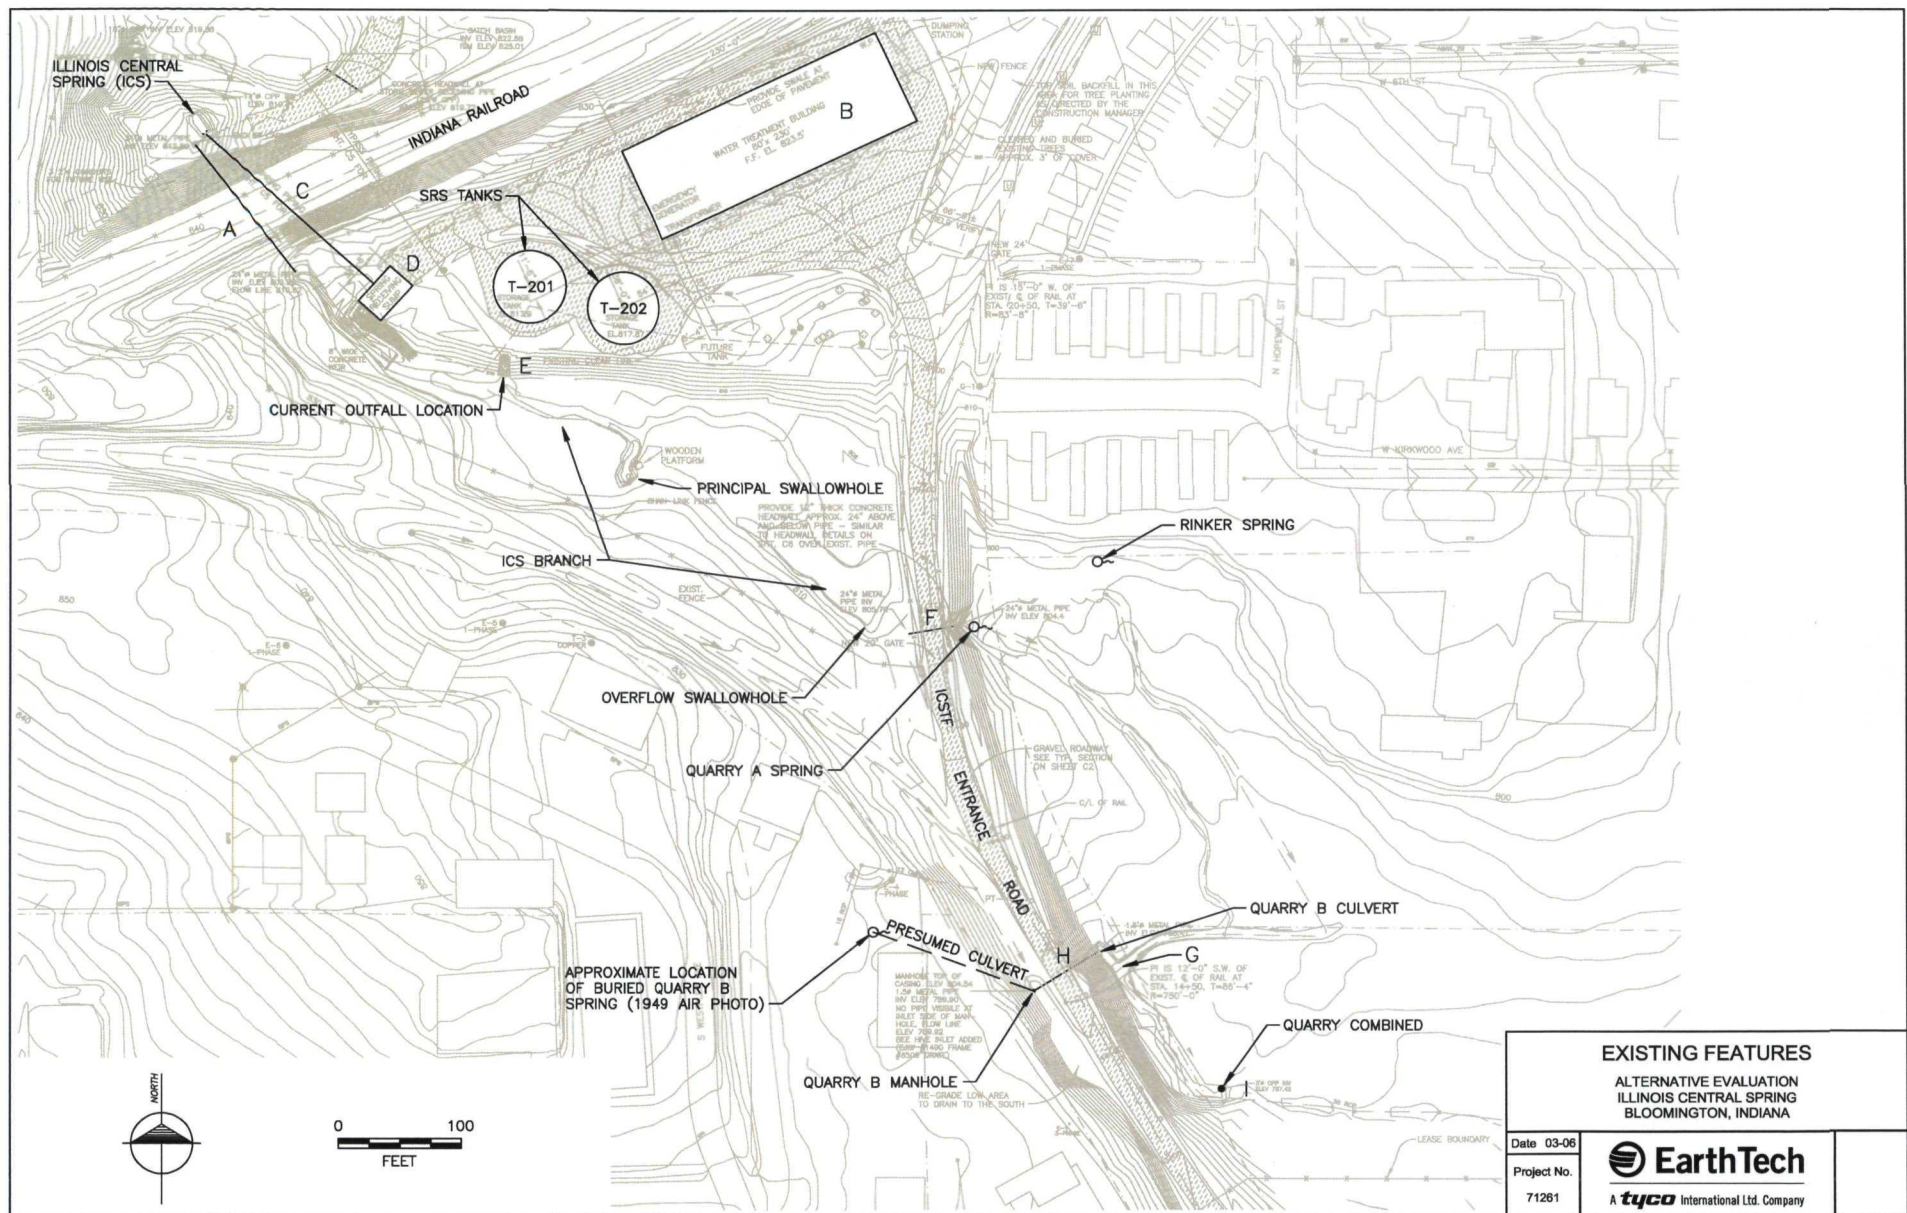
Figure 3. Site Features and the flow path of the effluent

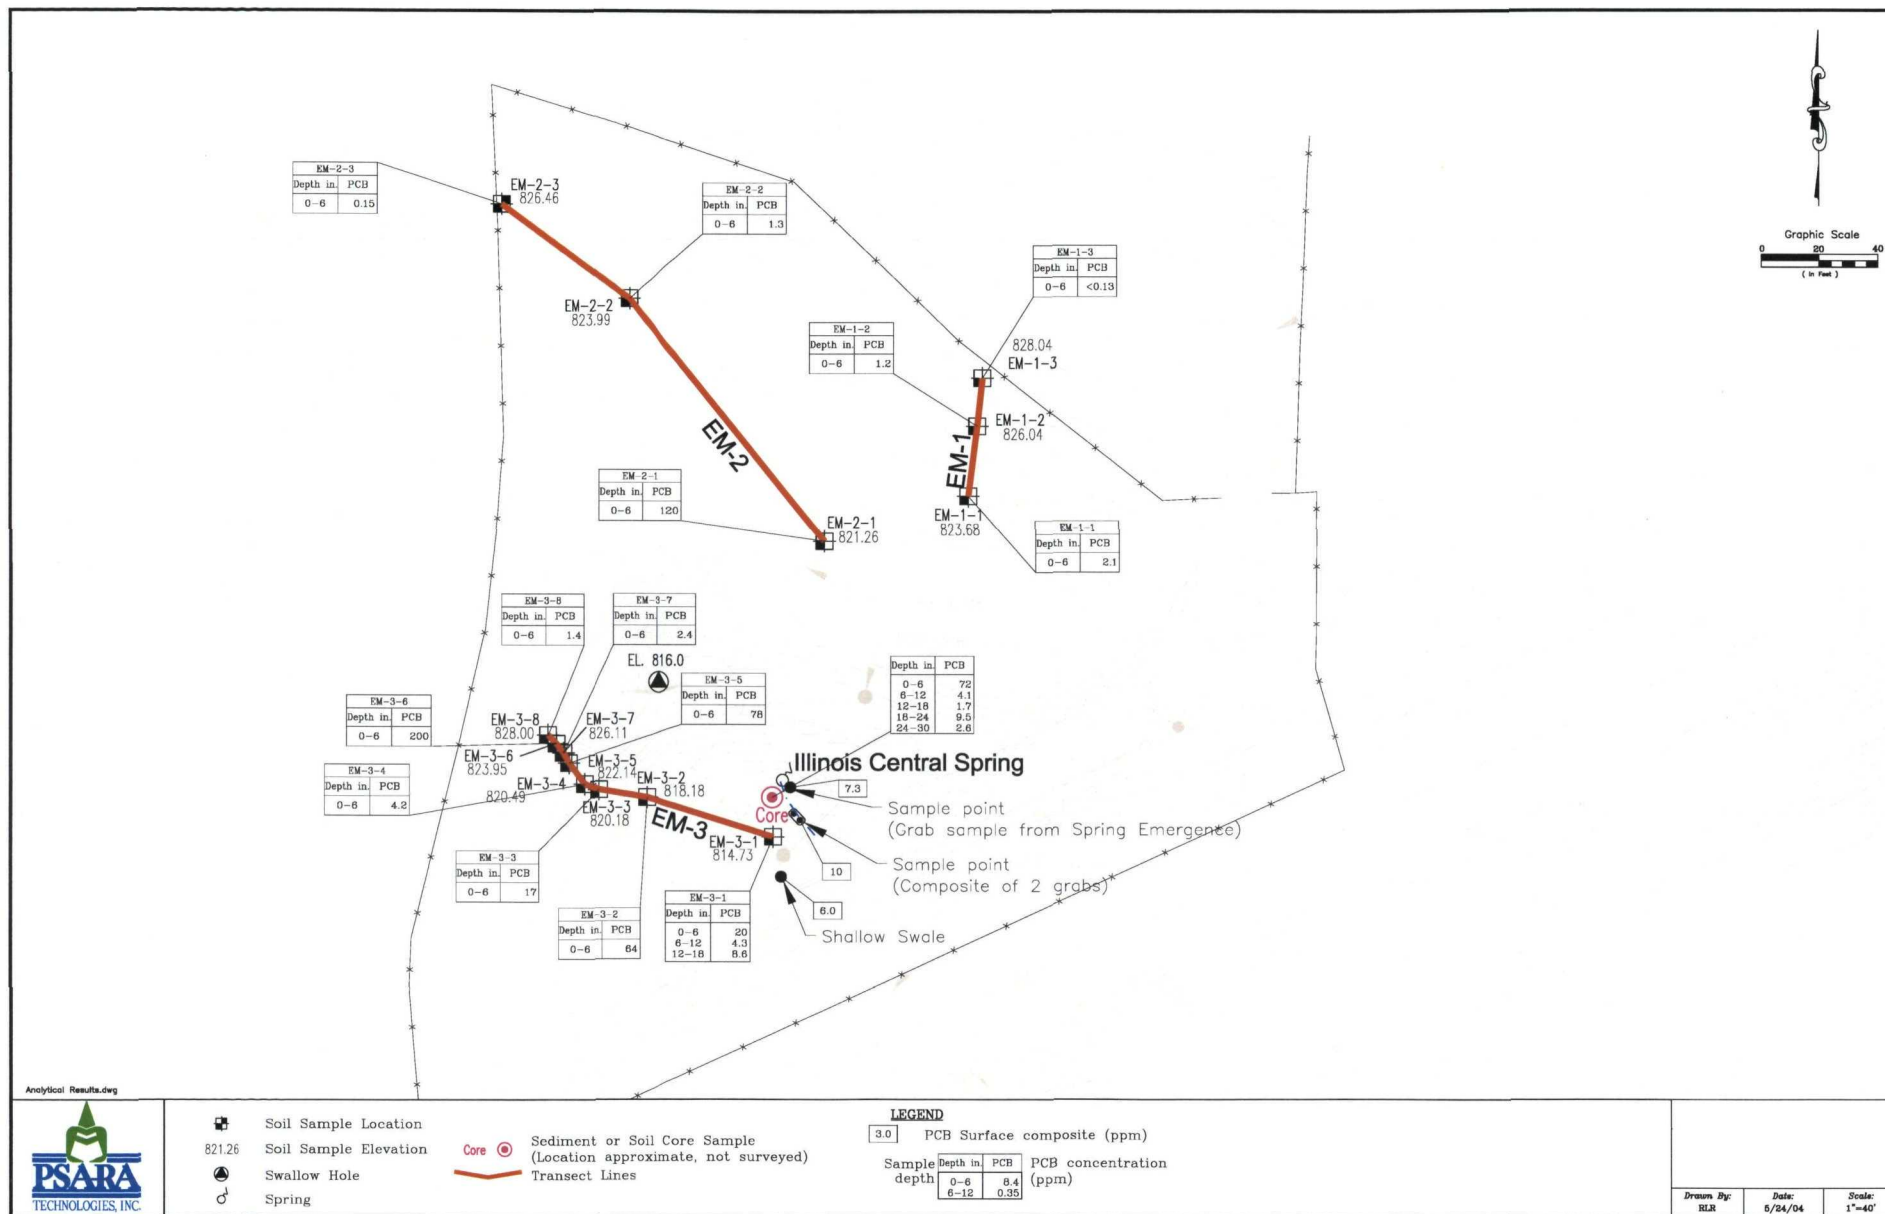
Figure 4. Sampling results at the ICS emergence

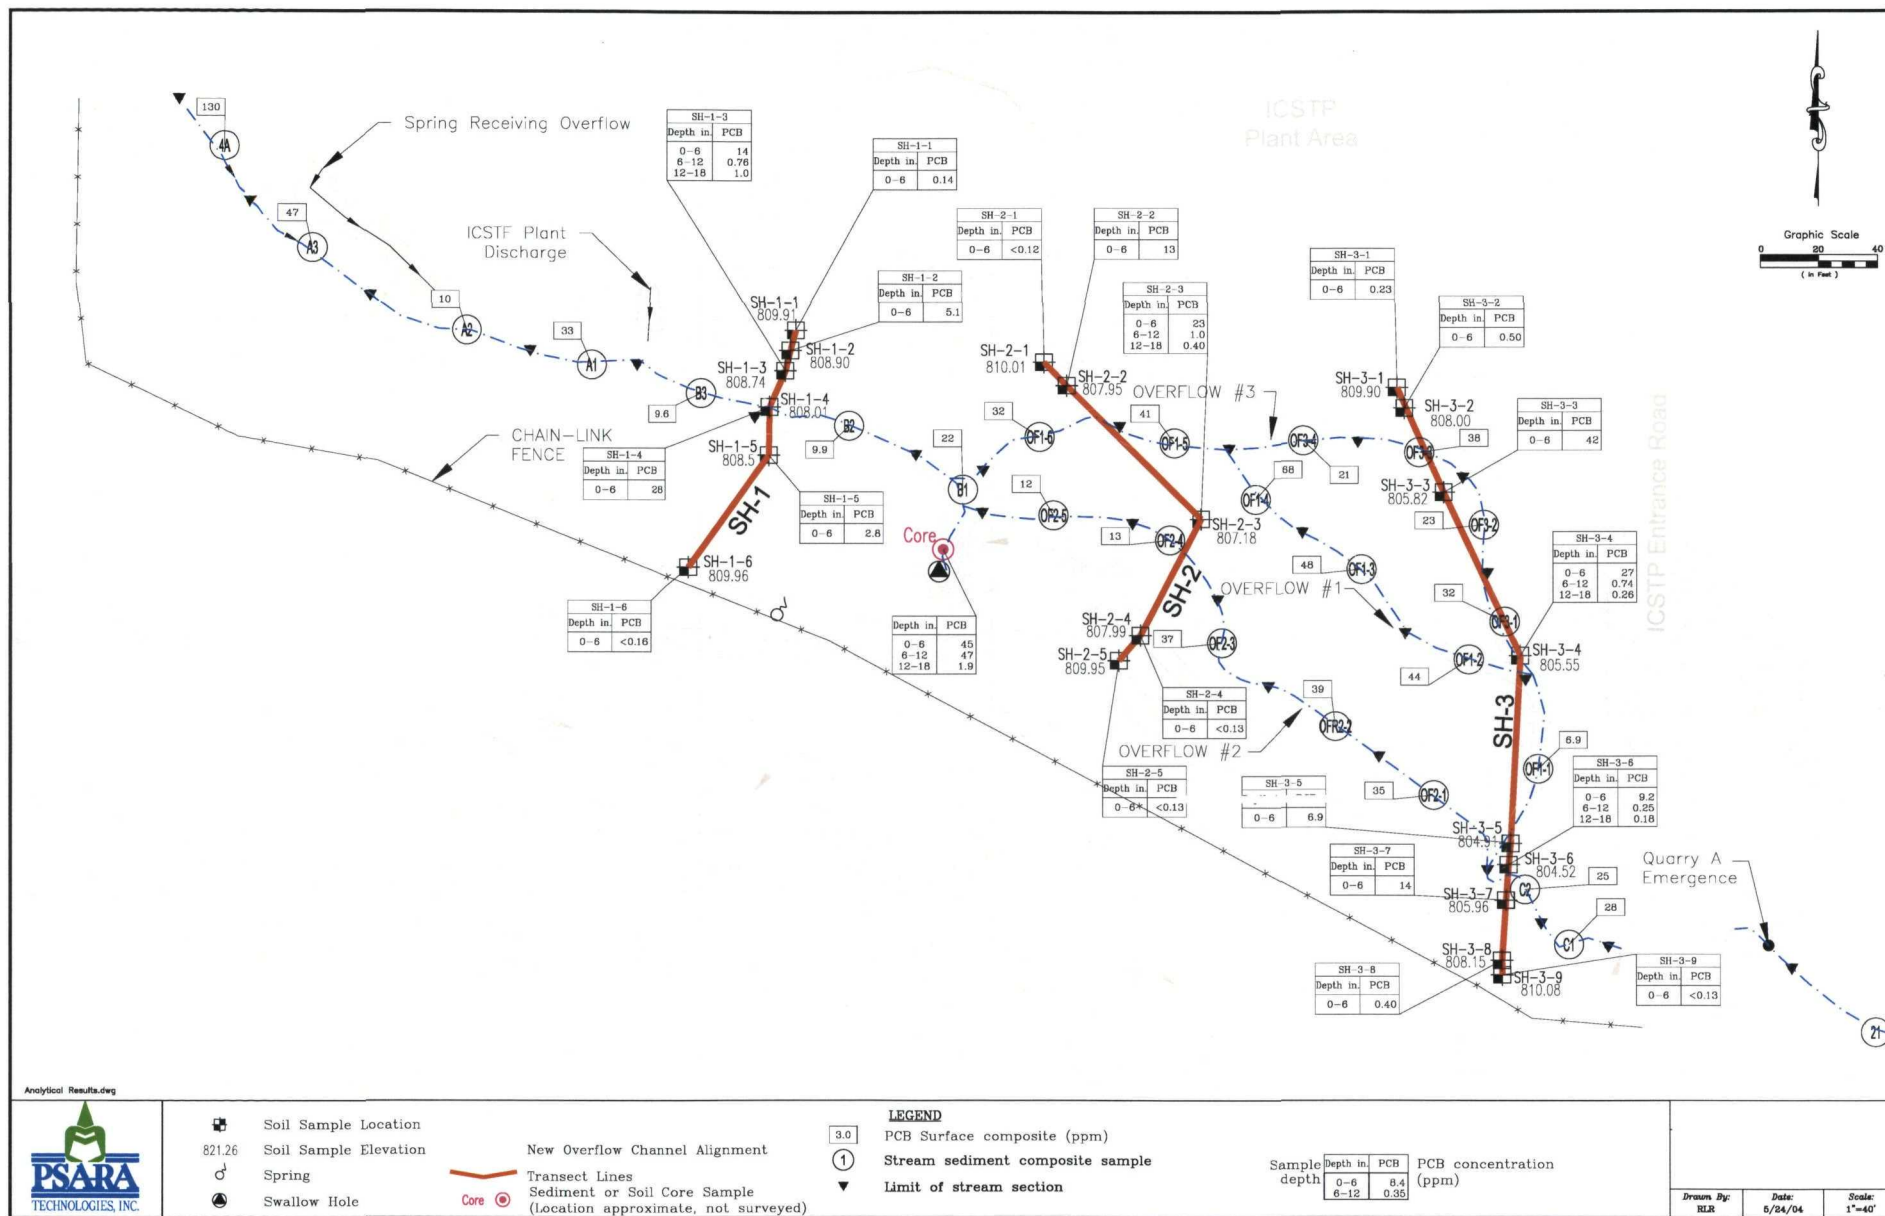
Figure 5. Sampling results at the swallowhole area

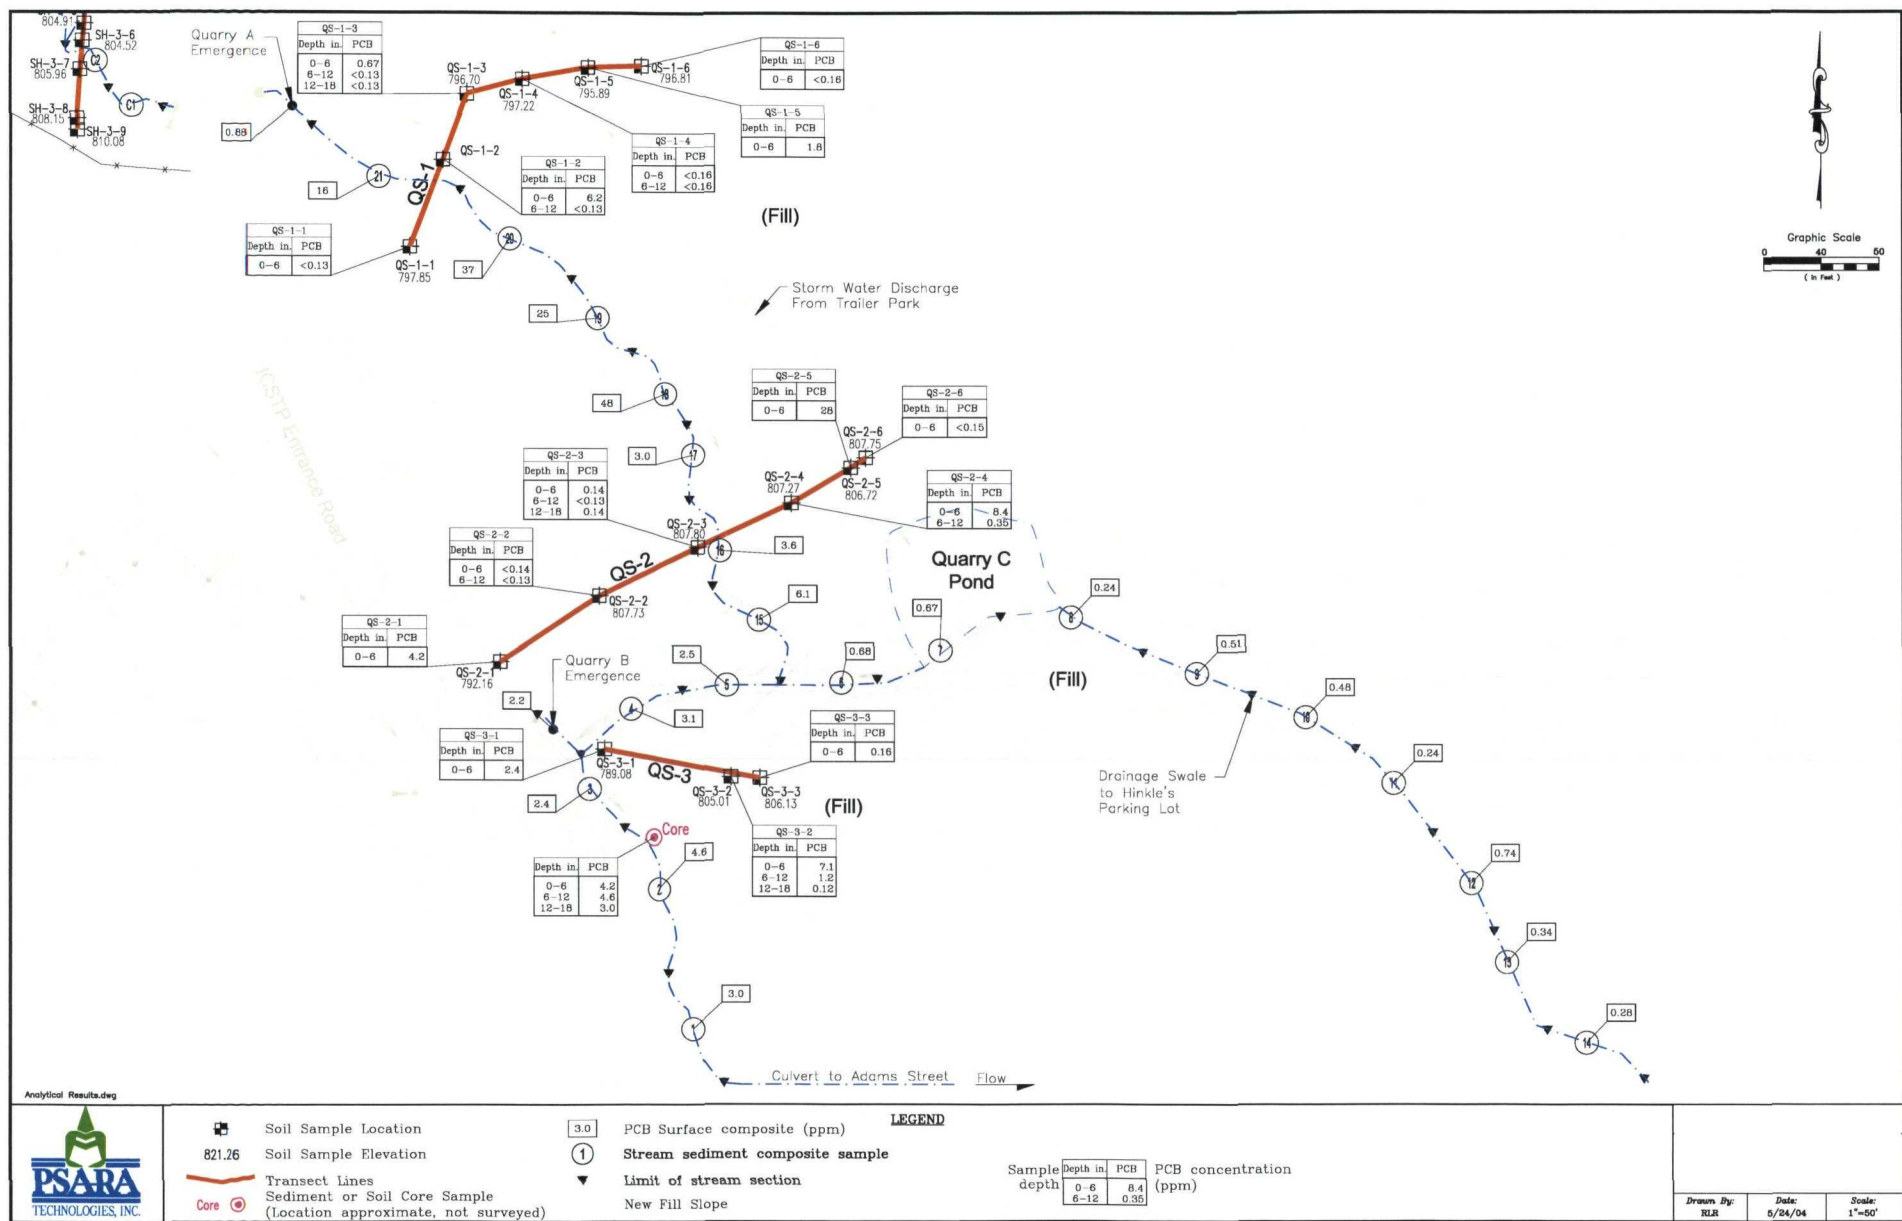
Figure 6. Sampling results at the Quarry springs area

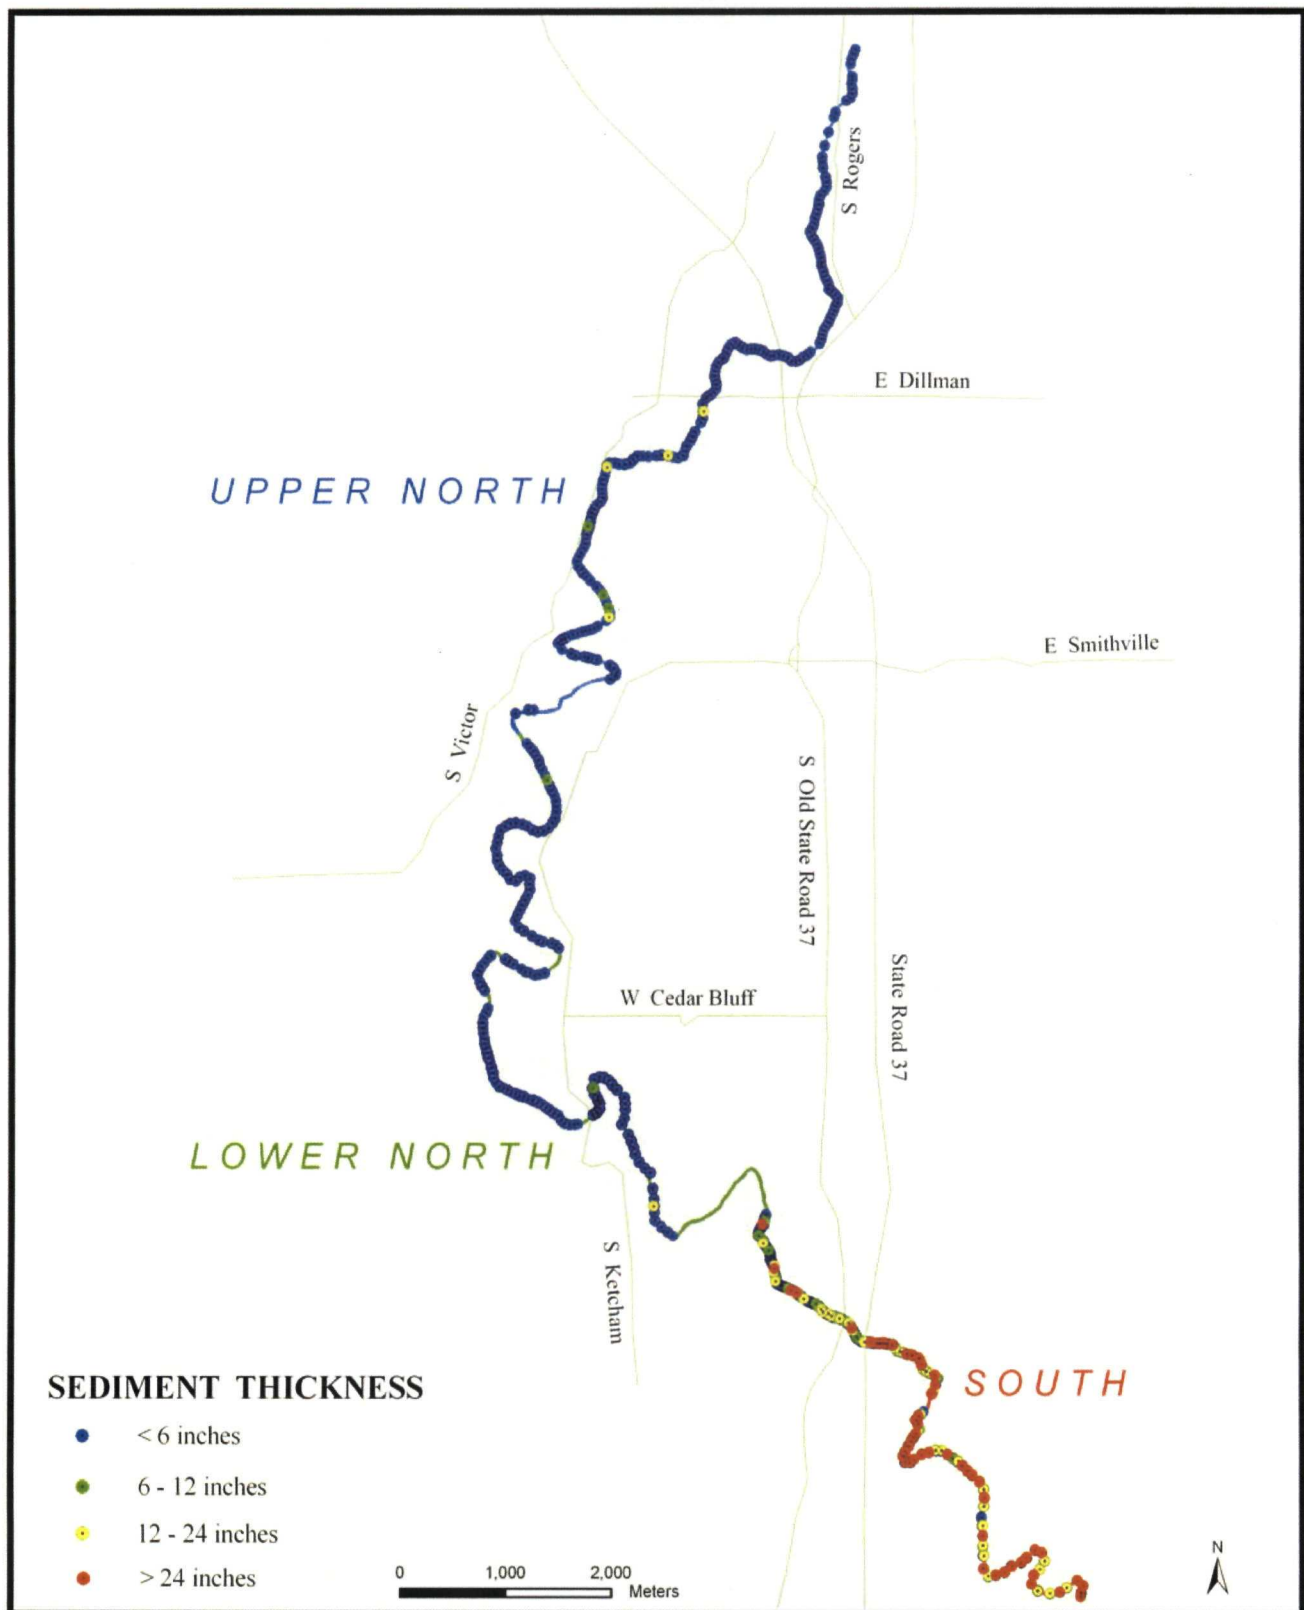
LOCATION OF SEDIMENT POKE SAMPLES USED
TO DETERMINE SEDIMENT THICKNESS

Figure 7. Representation of the sediment thickness in Clear Creek

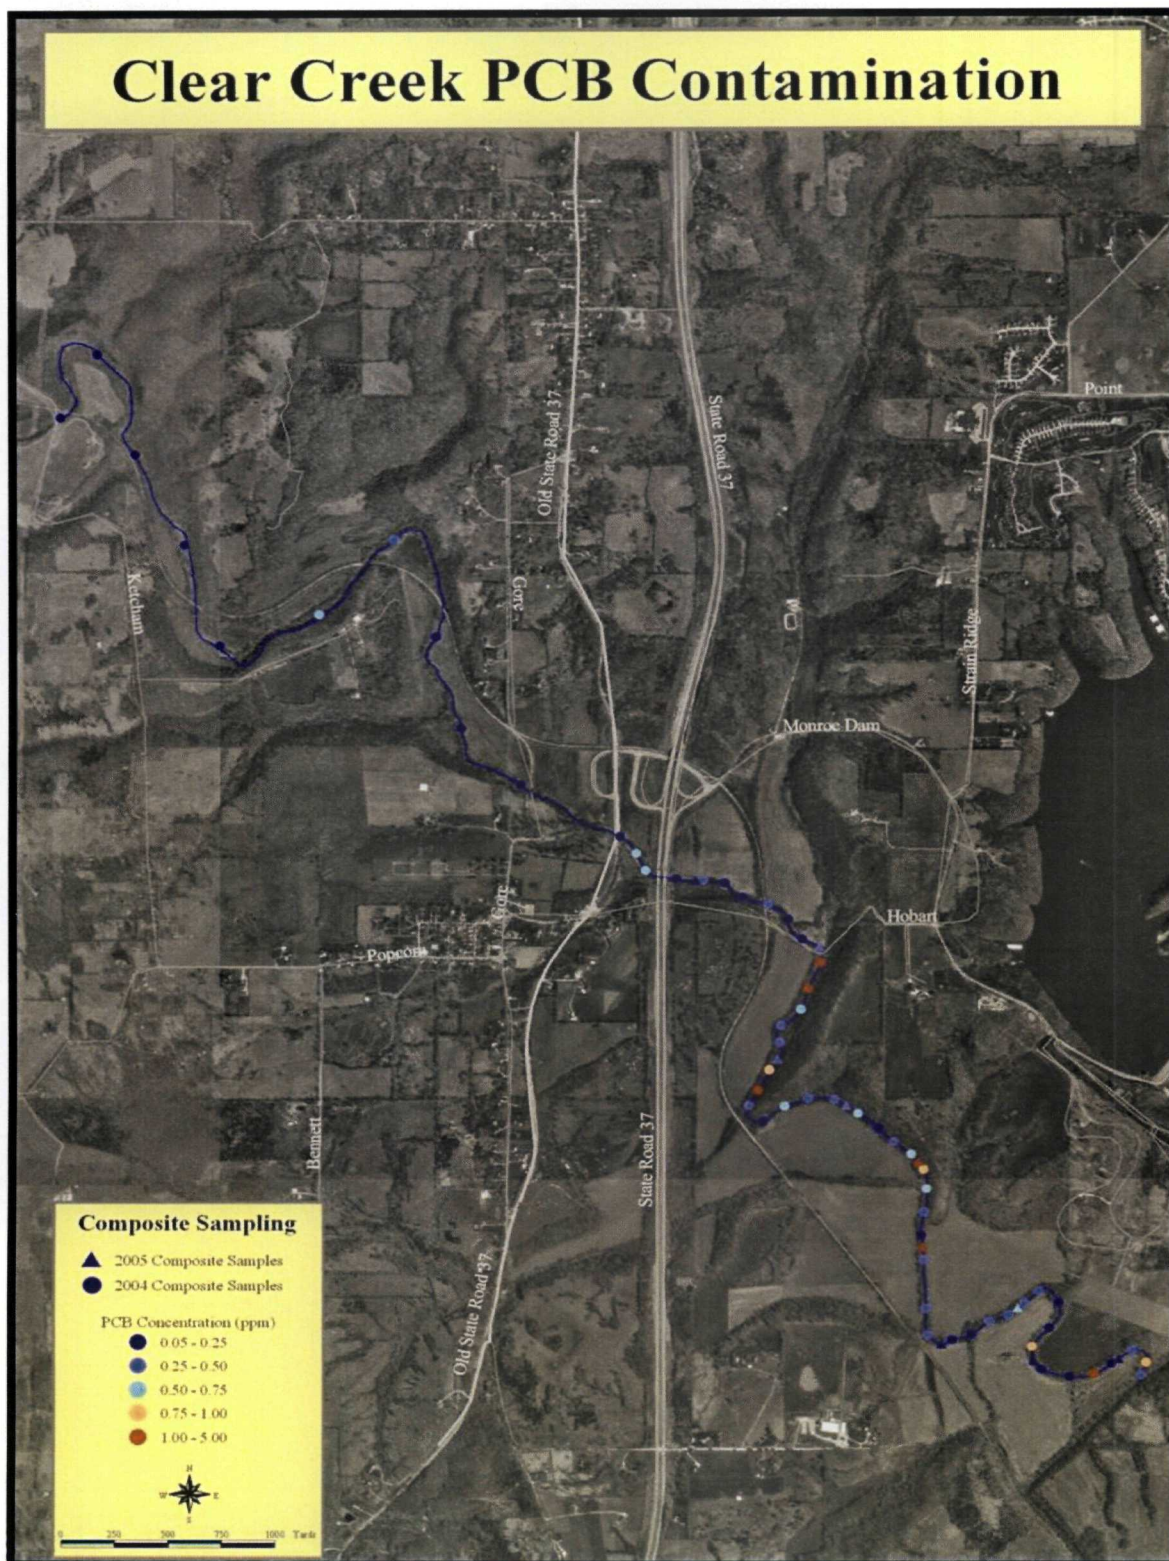
Figure 8. Results of the sediment sampling events in Clear Creek

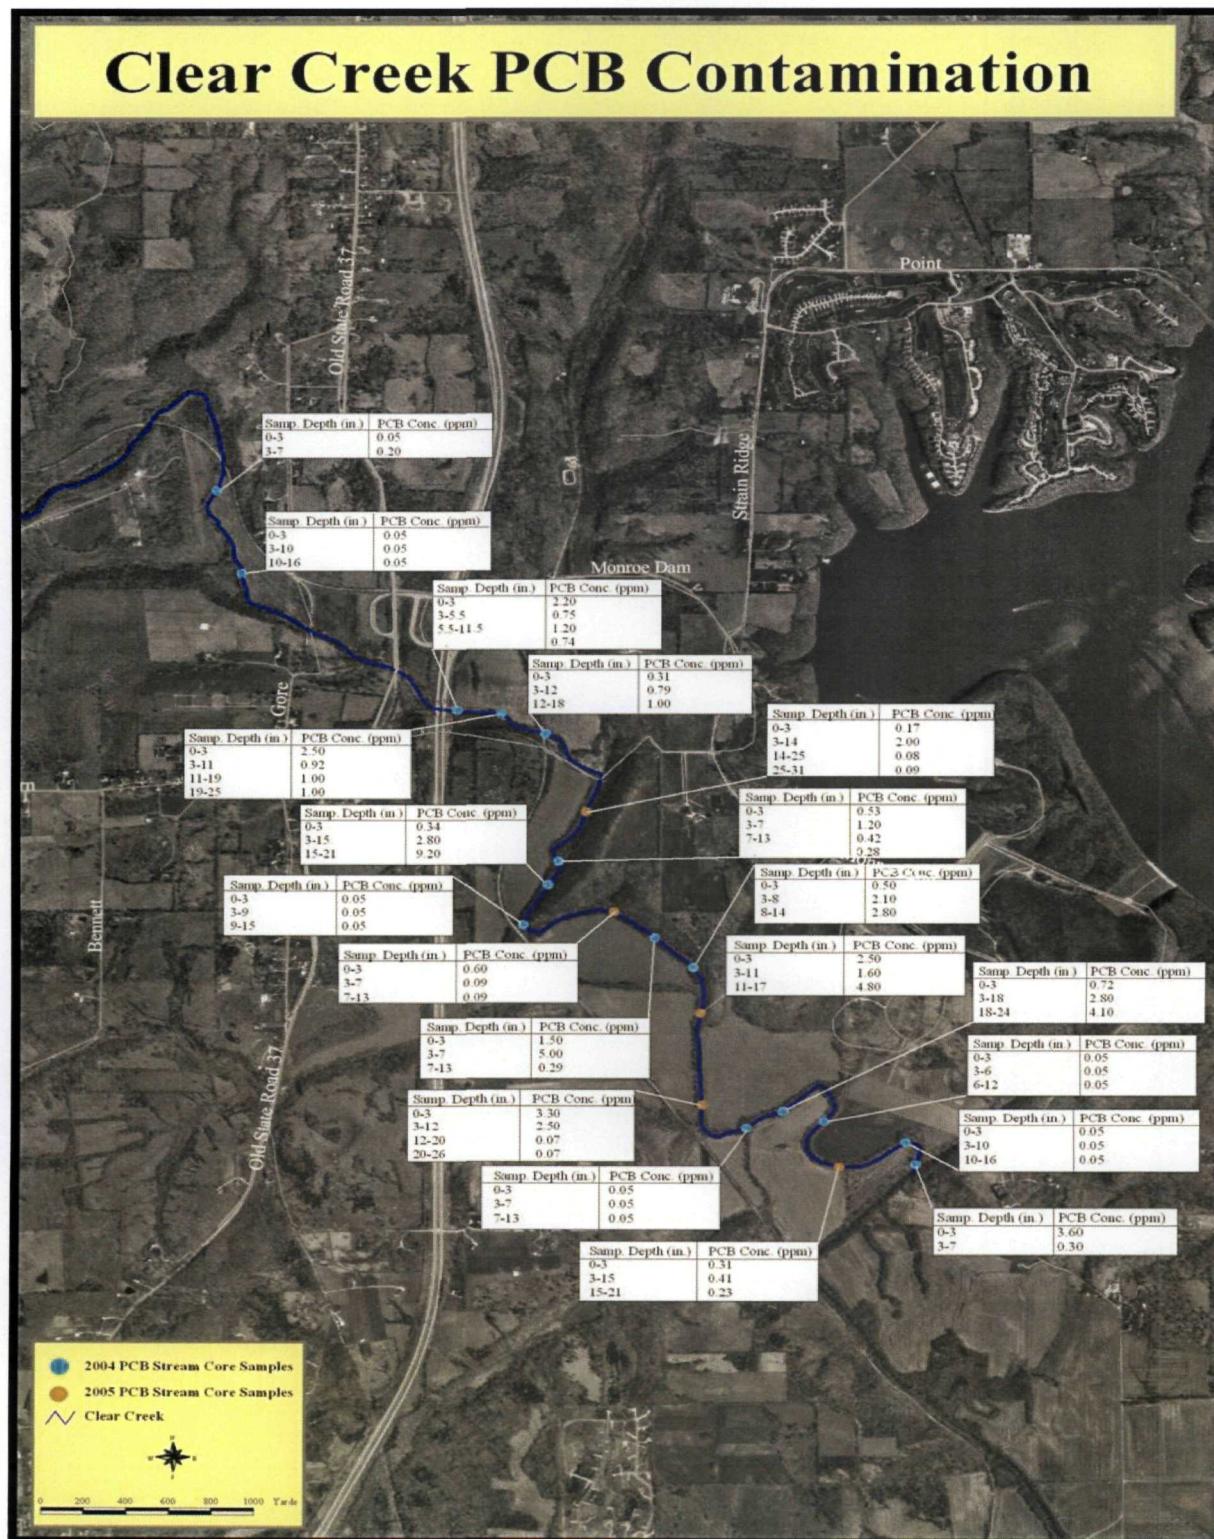
Figure 9. Results of the sediment sampling events in Clear Creek

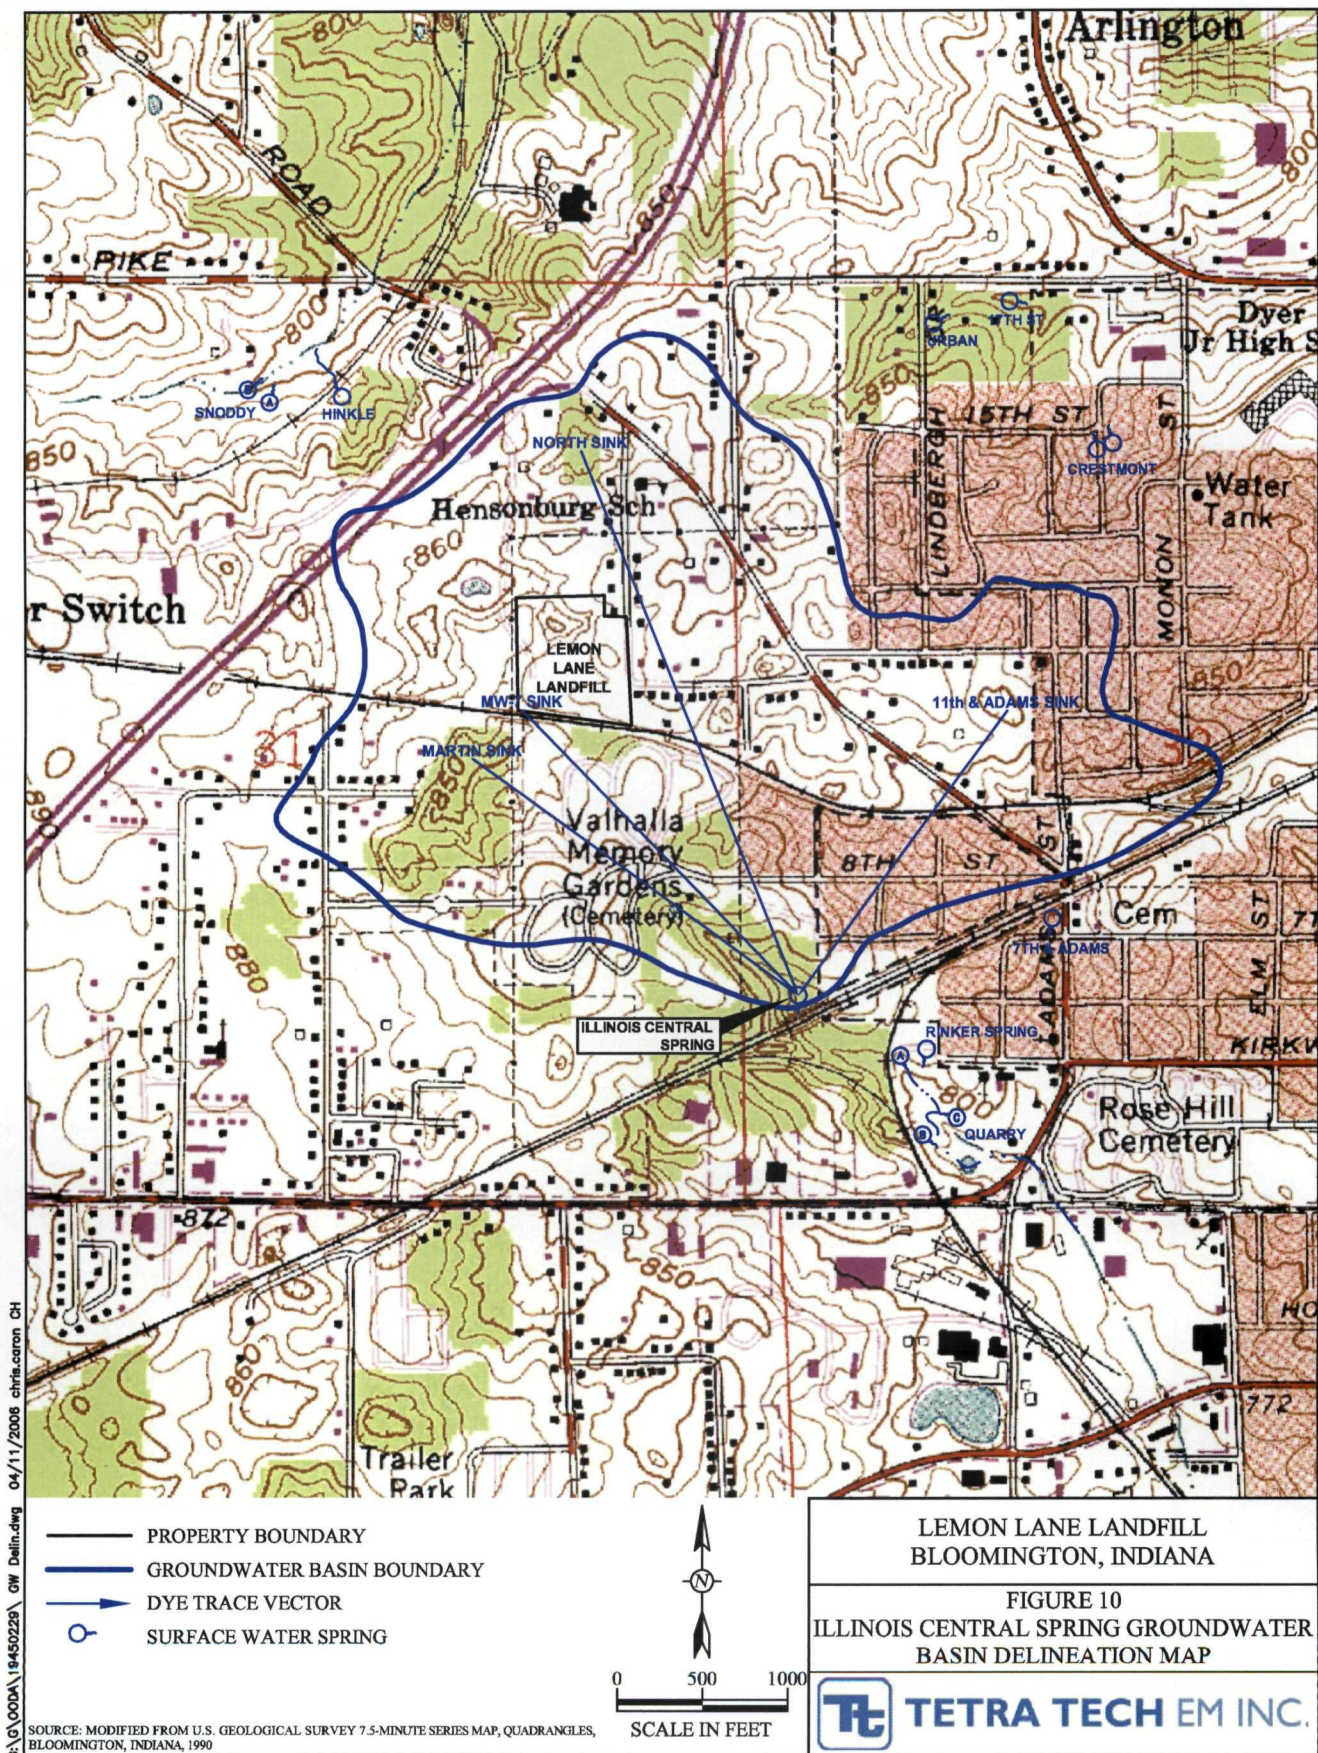
Figure 10. Delineation of the groundwater basin for ICS
